5 WTC 7

5.1 Introduction

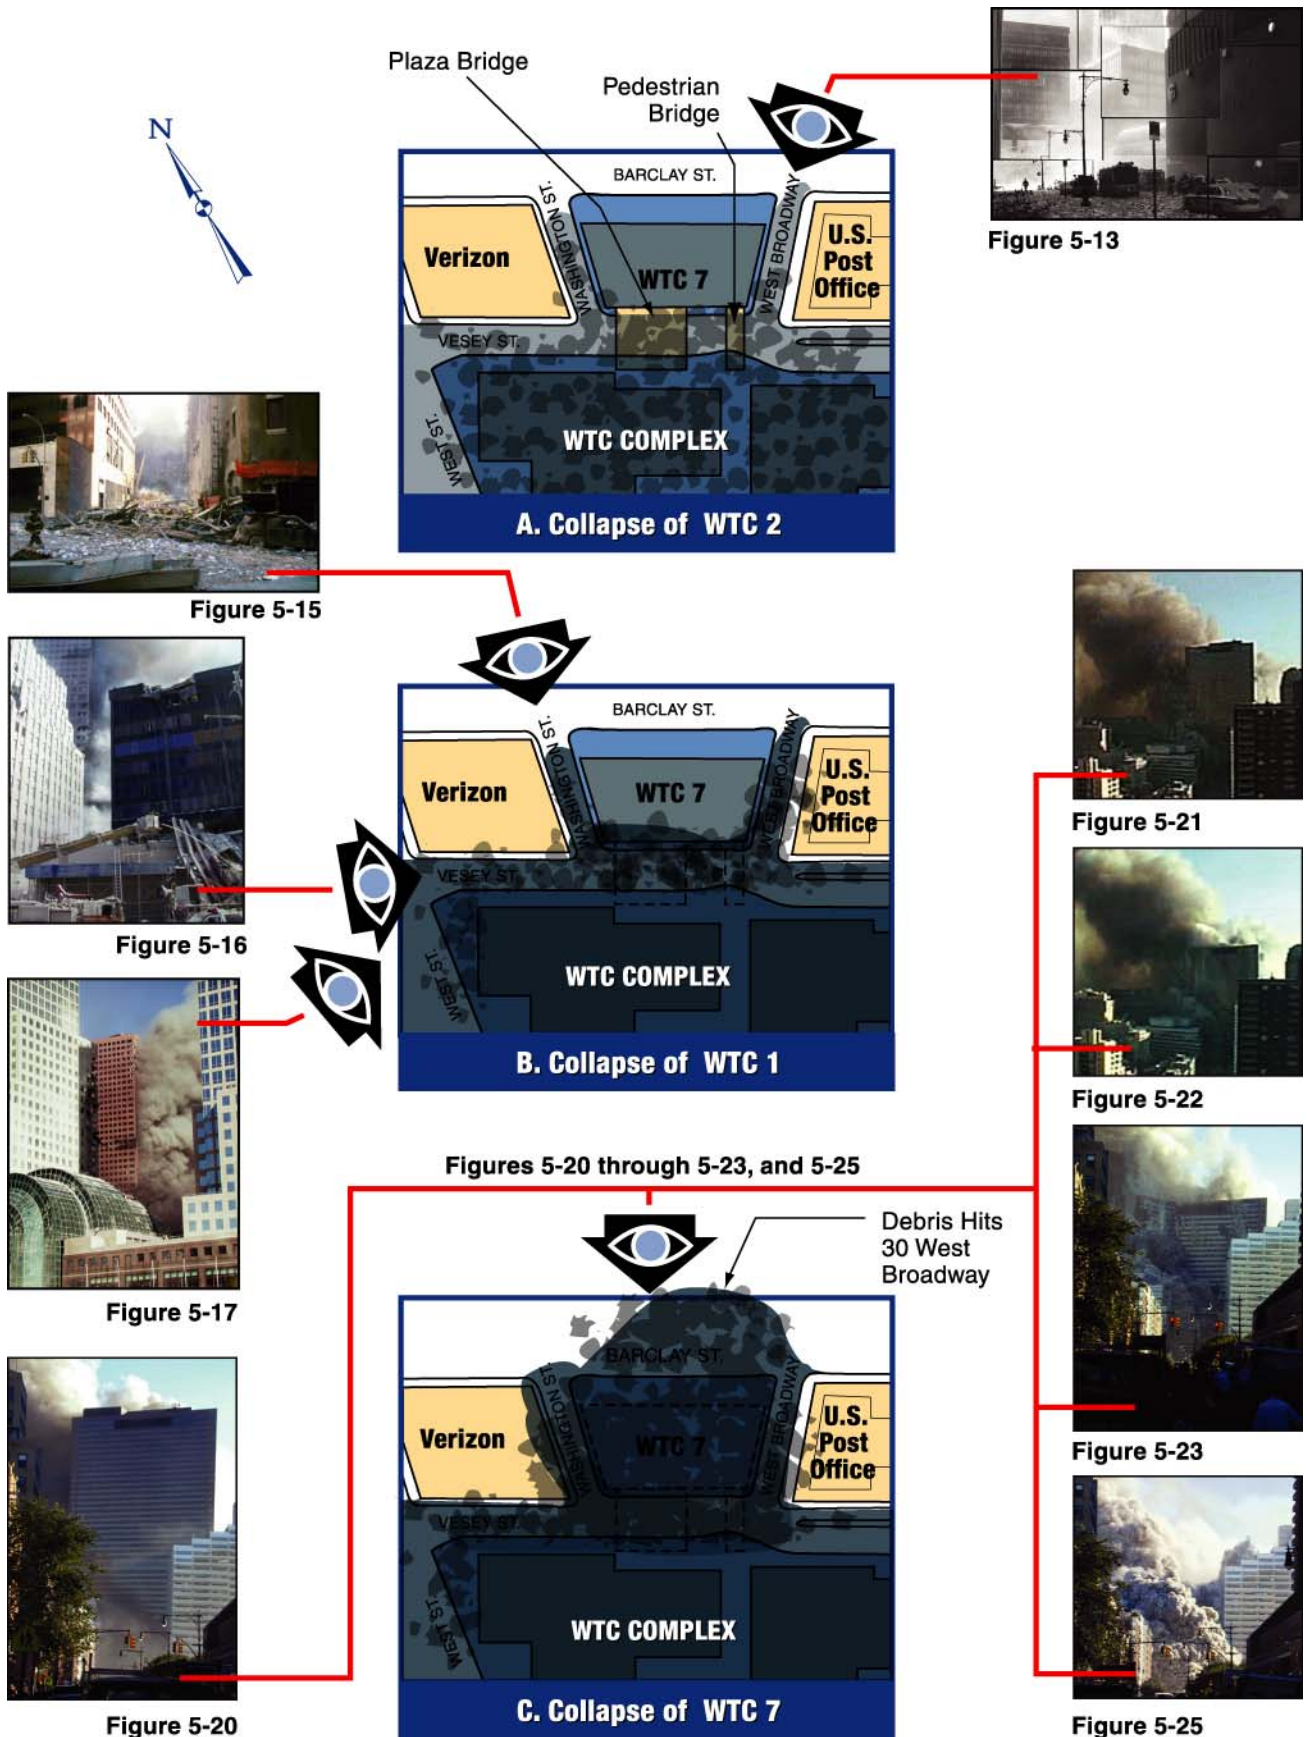
At 9:59 a.m., WTC 2 (the south tower) collapsed. The approximate extent of its debris is shown in Figure 5-12(A). It appears that the collapse of WTC 2 did not significantly affect the roof, or the east, west, and north elevations of WTC 7. It is unknown if there was any damage to the south elevation after WTC 2 collapsed, but both the covered, tubular pedestrian bridge (see Figure 5-13) and the Plaza bridge were still standing after the collapse of WTC 2.

Figure 5-12 Sequence of debris generated by collapses of WTC 2, 1, and 7.

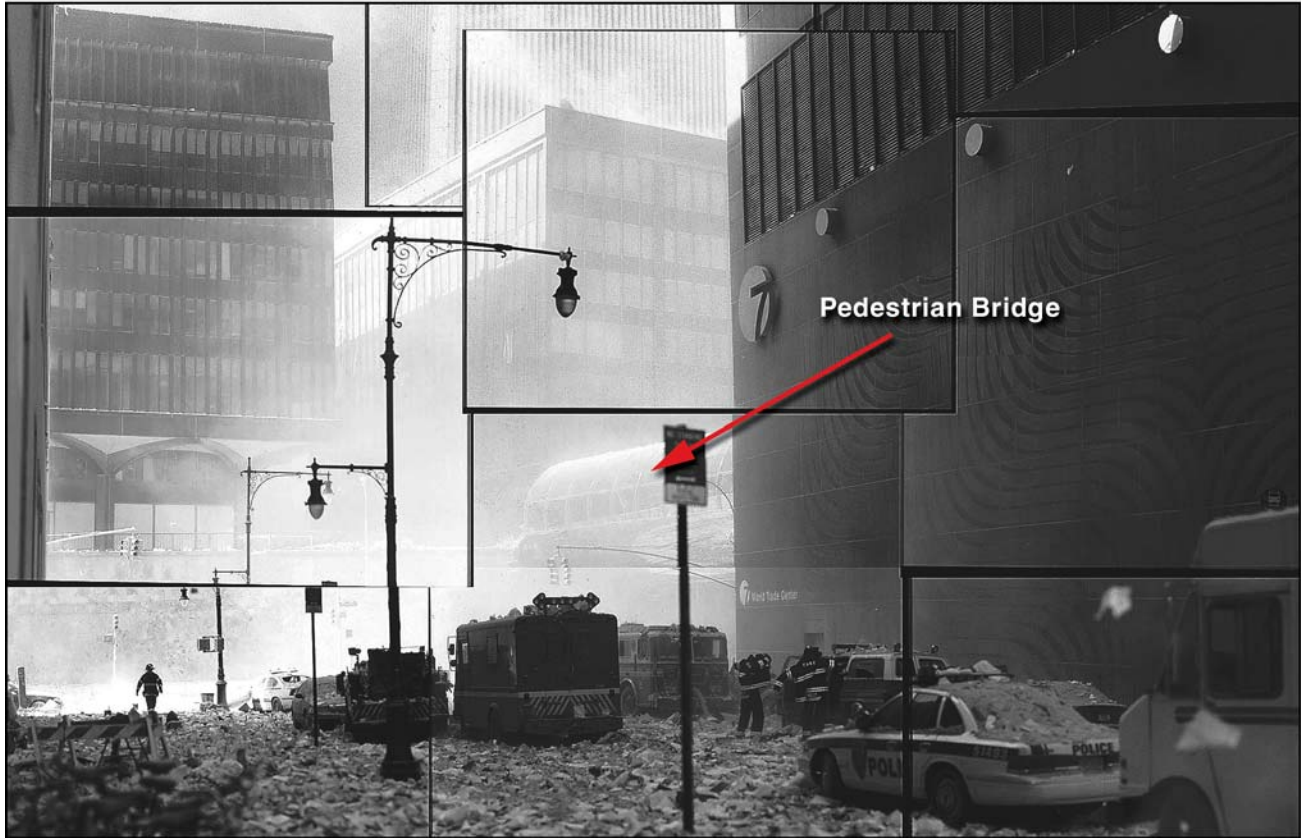
Figure 5-13 Pedestrian bridge (bottom center) still standing after WTC 2 has collapsed, sending substantial dust and debris onto the street, but before WTC 1 (top center) has collapsed.

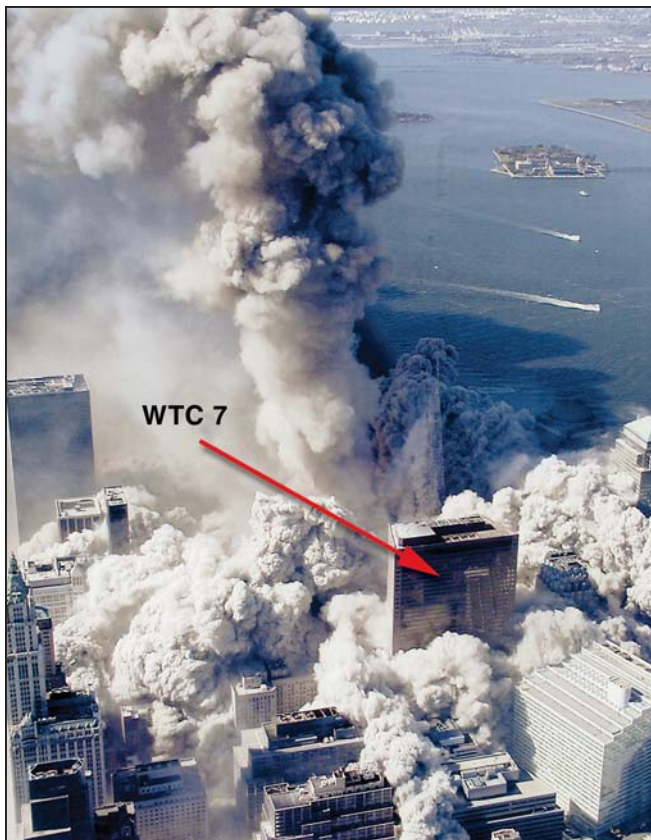
Figure 5-14 is an aerial photograph that shows the debris clouds spreading around WTC 7 just after the collapse of WTC 1. Figure 5-15 is a photograph of WTC 1 debris between the west elevation of WTC 7 and the Verizon building. Figure 5-12(B) shows a plan-view diagram approximating the extent of this debris just after the collapse of WTC 1.

Figure 5-14 View from the north of the WTC 1 collapse and the spread of debris around WTC 7. Note the two mechanical penthouses of WTC 7 are intact.

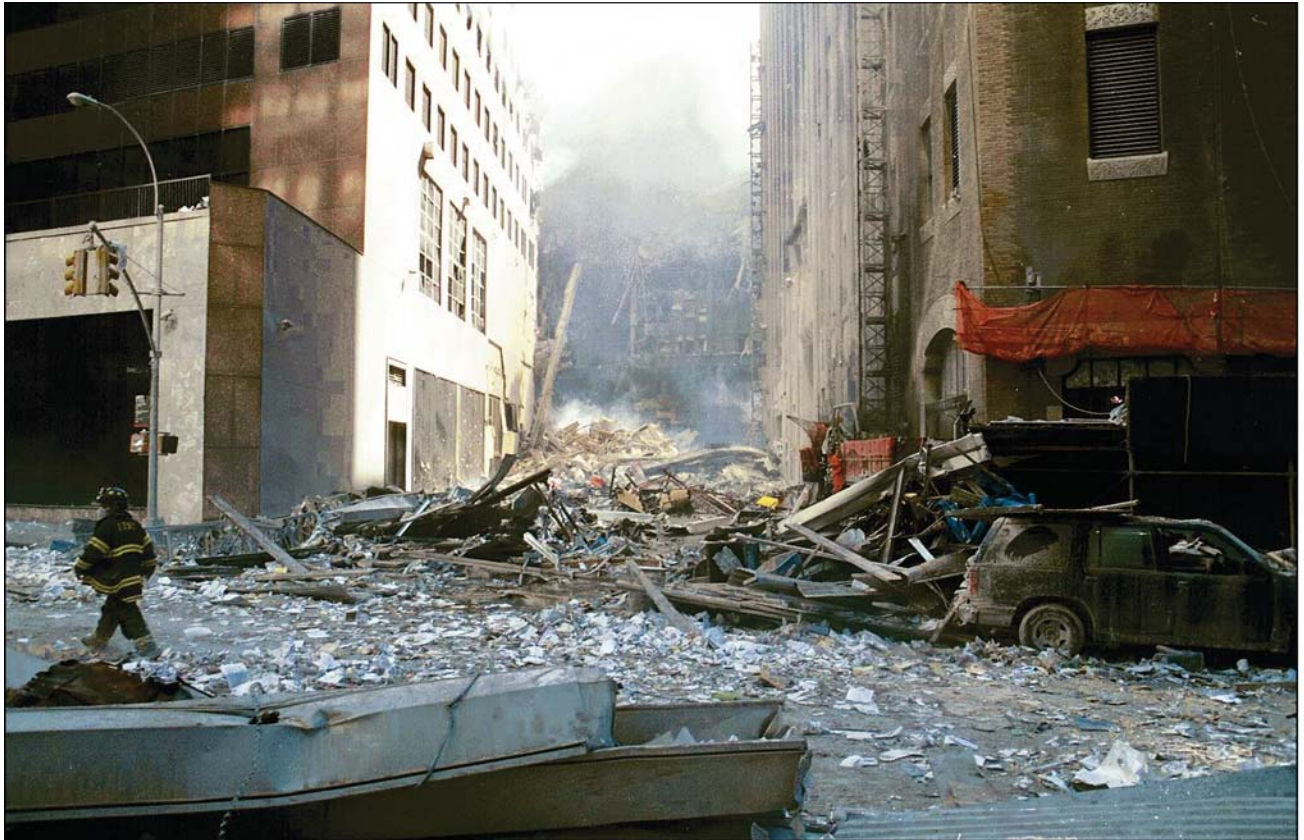
Figure 5-15 Debris from the collapse of WTC 1 located between WTC 7 (left) and the Verizon building (right).

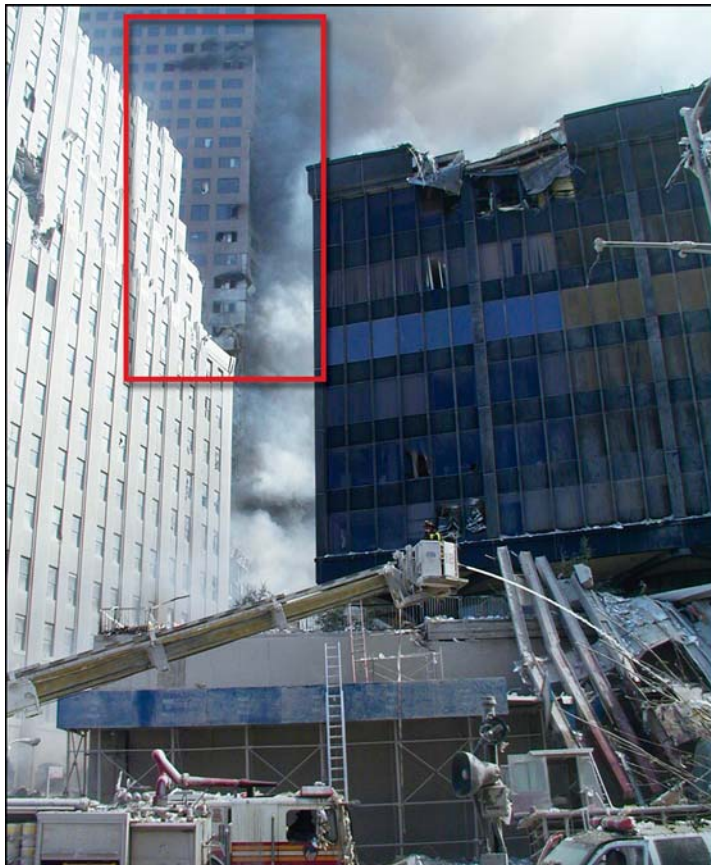
It does not appear that the collapse of WTC 1 affected the roof, or the east, west, and north elevations of WTC 7 in any significant way. However, there was damage to the southwest corner of WTC 7 at approximately floors 8 to 20, 24, 25, and 39 to 46, as shown in Figure 5-16, a photograph taken from West Street.

Figure 5-16 Damage to southwest corner of WTC 7 (see box), looking from West Street.

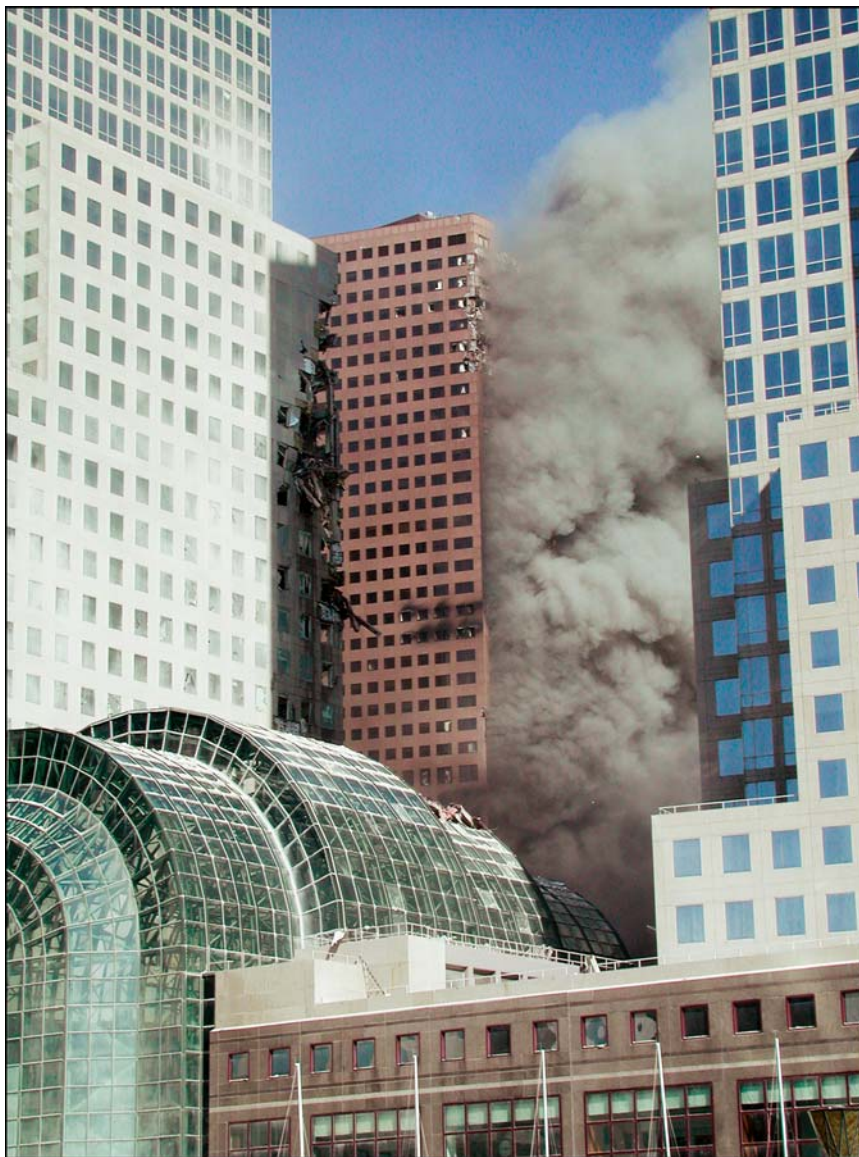
Figure 5-17, a photograph taken across from the World Financial Center (WFC), shows the west elevation and indicates damage at the southwest corner of WTC 7 at the 24th, 25th, and 39th through 46th floors.

*Figure 5-17
Building damage to the southwest corner and smoke plume from south face of WTC 7, looking from the World Financial Plaza. Note damage to WFC 3 in the foreground.*

Video footage indicated that the majority of the smoke appeared to be coming from the south side of the building at that time as opposed to the other sides of the building. This is corroborated by Figure 5-17, a photograph taken at 3:36 p.m. that shows the south face of WTC 7 covered with a thick cloud of smoke, and only small amounts of smoke emanating from the 27th and 28th floors of the west face of WTC 7.

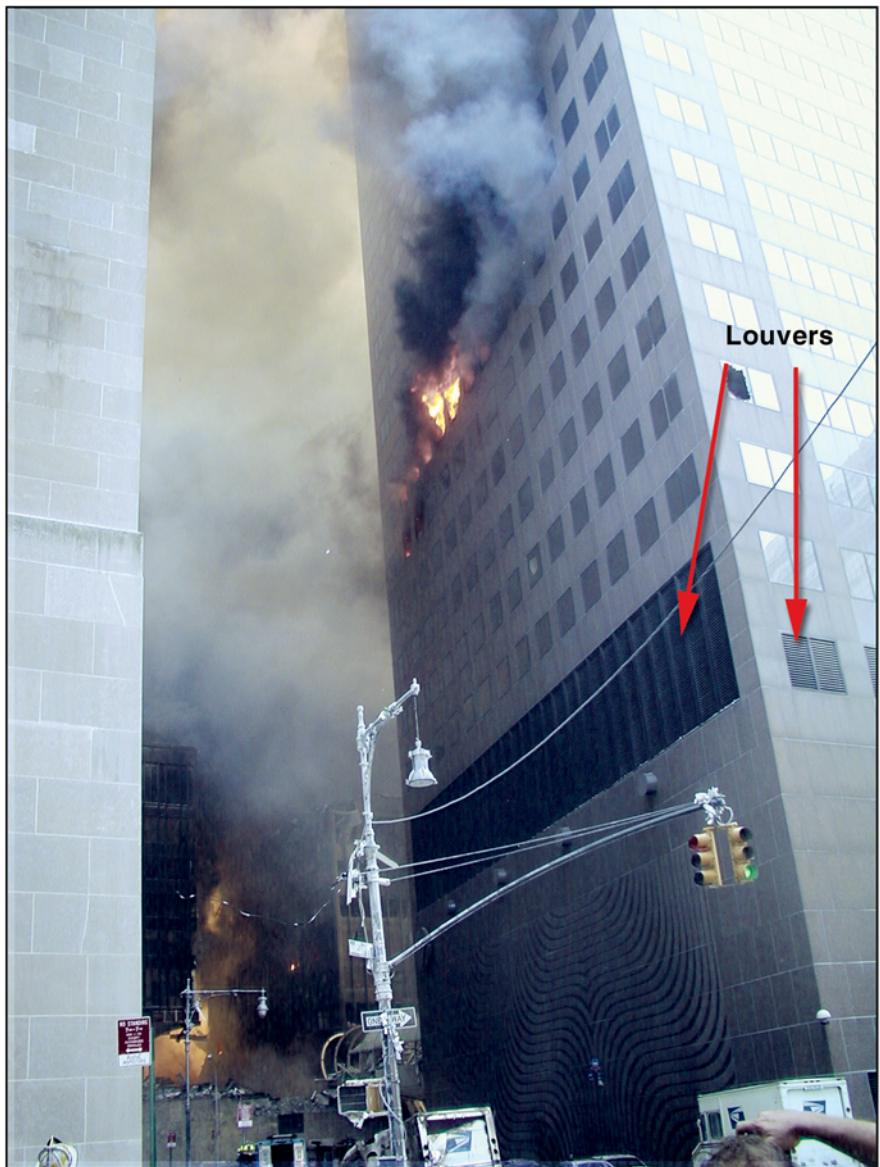
As the day progressed, fires were observed on the east face of the 11th, 12th, and 28th floors (see Figure 5-19). The Securities and Exchange Commission occupied floors 11 through 13. Prior to collapse, fire was seen to have broken out windows on at least the north and east faces of WTC 7 on some of the lower levels.

Figure 5-19
Fires on the 11th and 12th floors of
the east face of WTC 7.

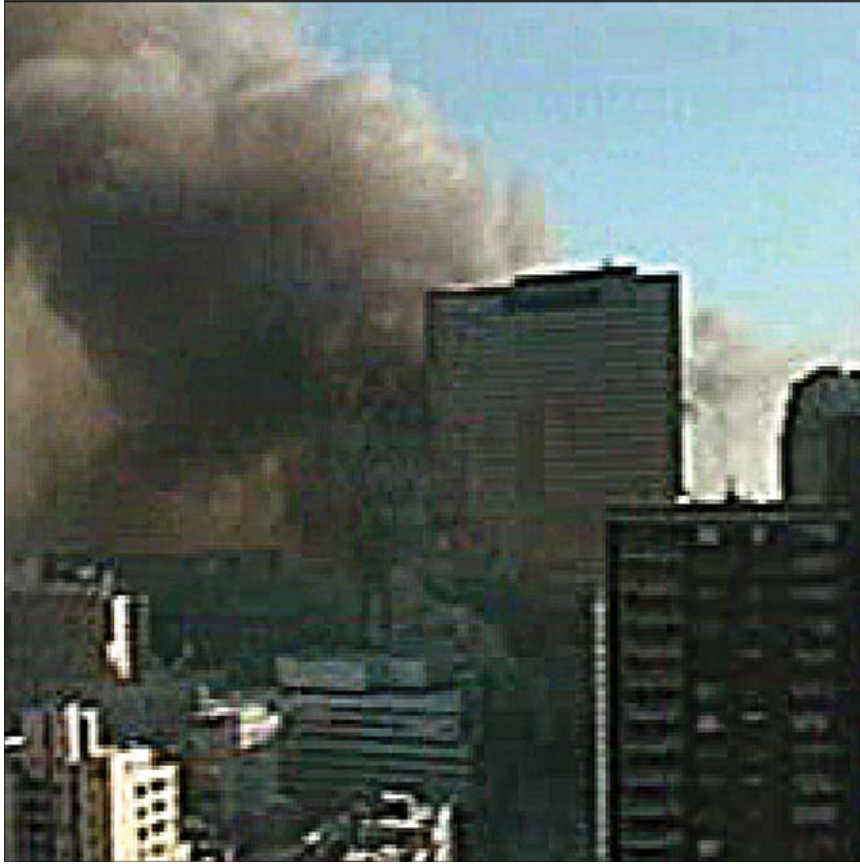
*Figure 5-21
East mechanical penthouse collapsed.
(From video.)*

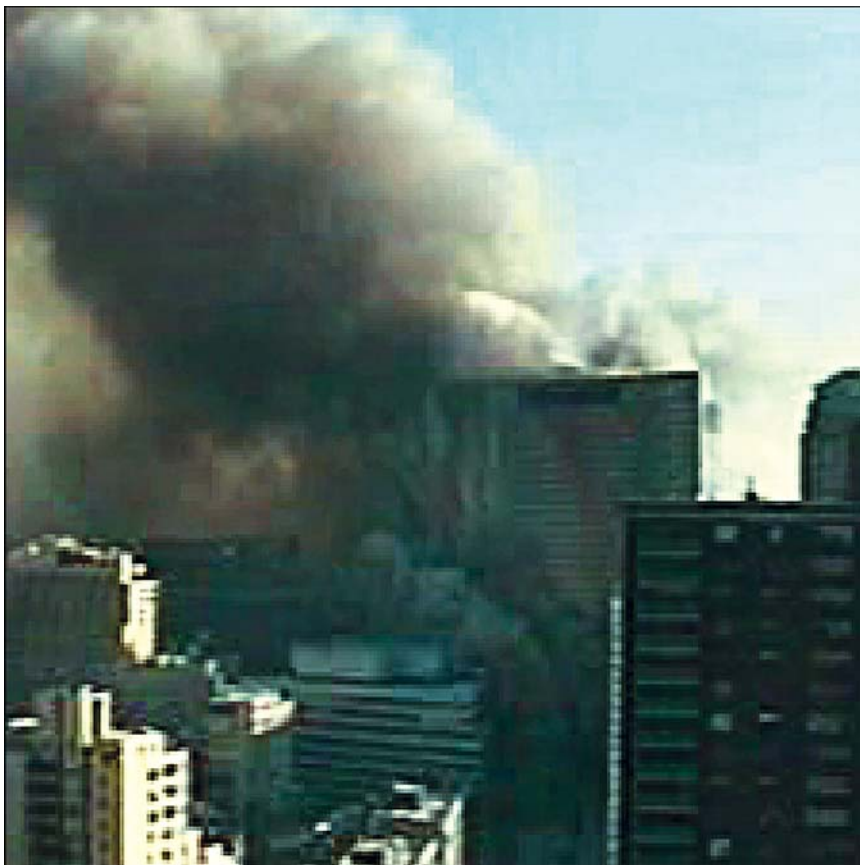
*Figure 5-22
East and now west mechanical
penthouses gone. (From video.)*

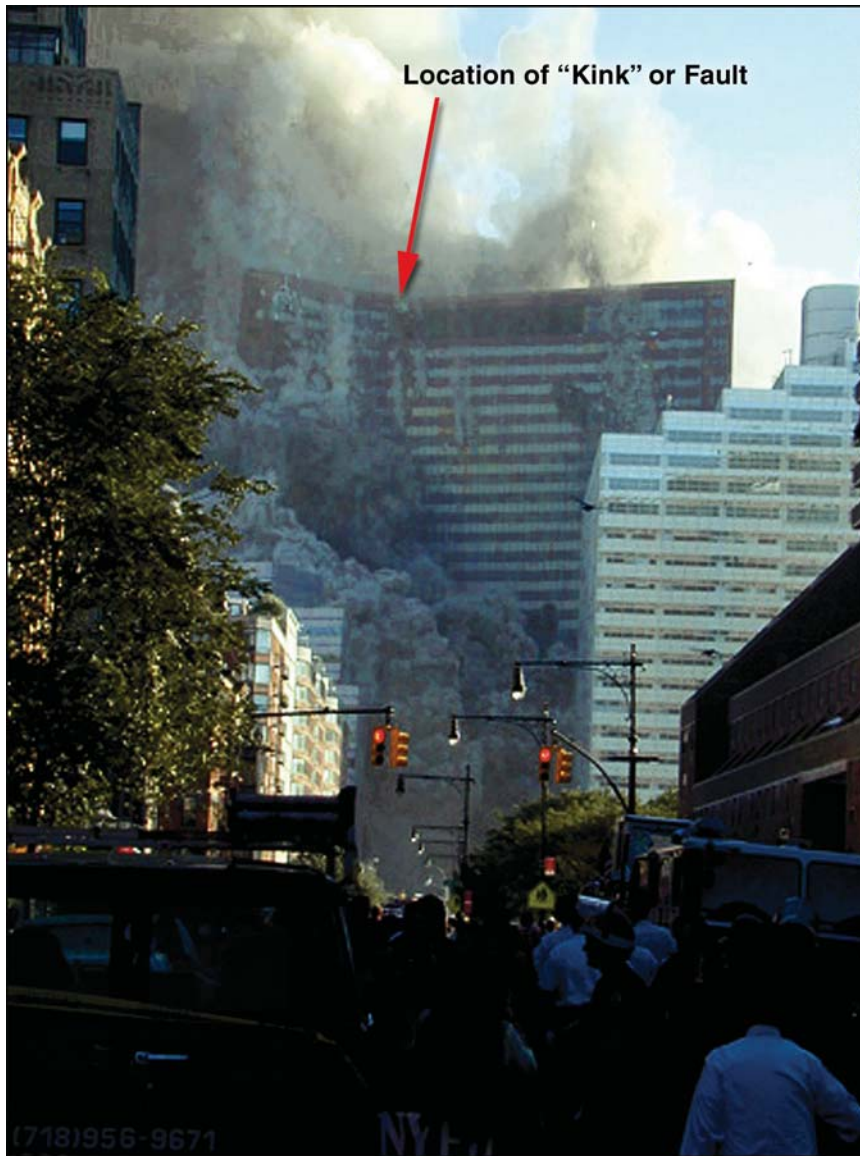
~5:21:09 p.m. Approximately 1 or 2 seconds after the west penthouse sinks into WTC 7, the whole building starts to collapse. A north-south “kink” or fault line develops along the eastern side as the building begins to come down at what appears to be the location of the collapse initiation (see Figures 5-23 and 5-24).

Figure 5-23
View from the north of the “kink” or fault developing in WTC 7.

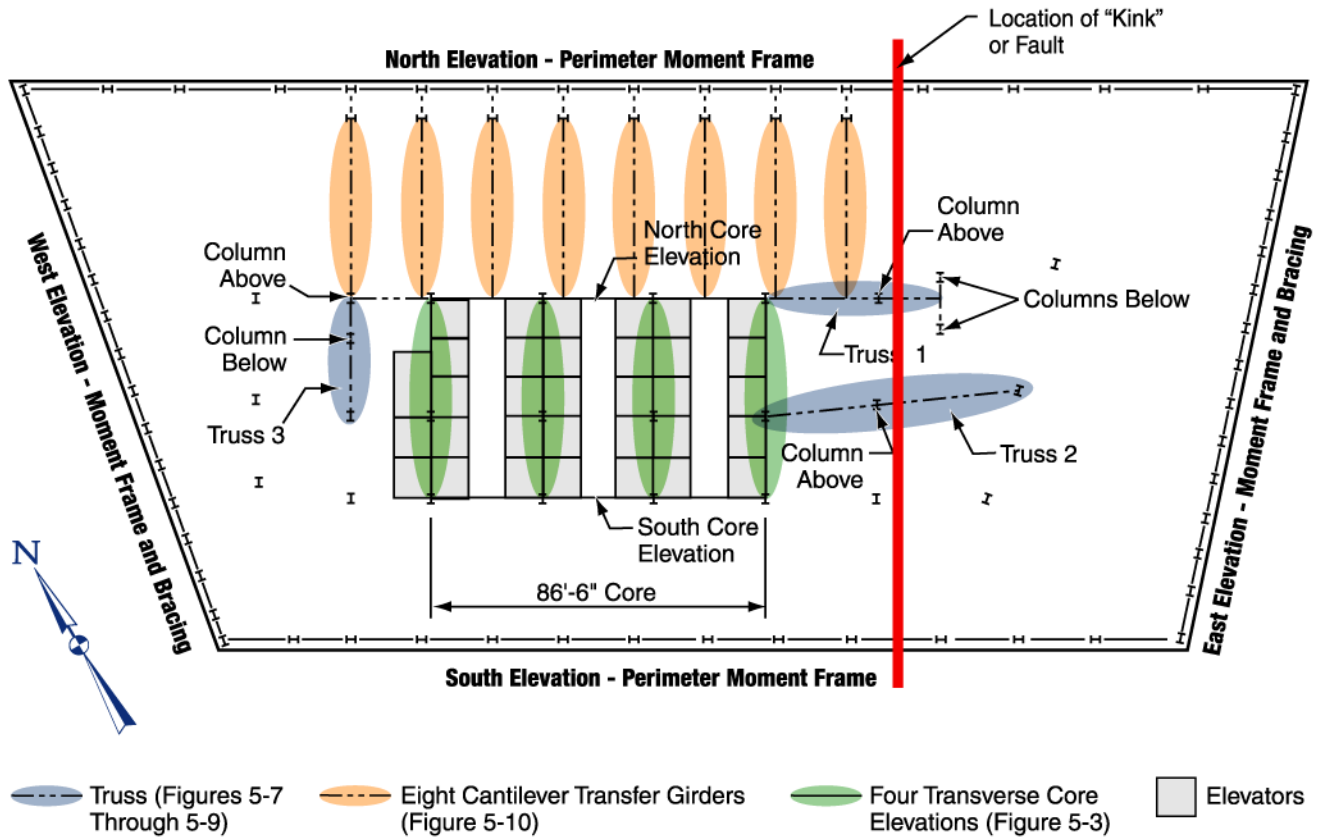
Figure 5-24 Areas of potential transfer truss failure.

5th Floor Scenarios. From a structural standpoint, the most likely event would have been the collapse of Truss 1 and/or Truss 2 located in the east end of the 5th and 6th floors. These floors are believed to have contained little if any fuel other than the diesel fuel for the emergency generators, making diesel oil a potential source of fire. As noted in Section 5.4, the fuel distribution system for the emergency generators pumped oil from tanks on the lower floors to the generators through a pipe distribution system. The SSB fuel oil system was a more likely source of fire around the transfer trusses. The SSB pump is reported as a positive displacement pump having a capacity of 75 gpm at 50 psi. Fuel oil was distributed through the 5th floor in a double-wall iron pipe. A portion of the piping ran in close proximity to Truss 1. However, there is no physical, photographic, or other evidence to substantiate or refute the discharge of fuel oil from the piping system.

During the course of the day, fires may have exposed various structural elements to high temperatures for a sufficient period of time to reduce their strength to the point of causing collapse. The structural elements most likely to have initiated the observed collapse are the transfer trusses between floors 5 to 7, located on lower floors under the east mechanical penthouse close to the fault/kink location.

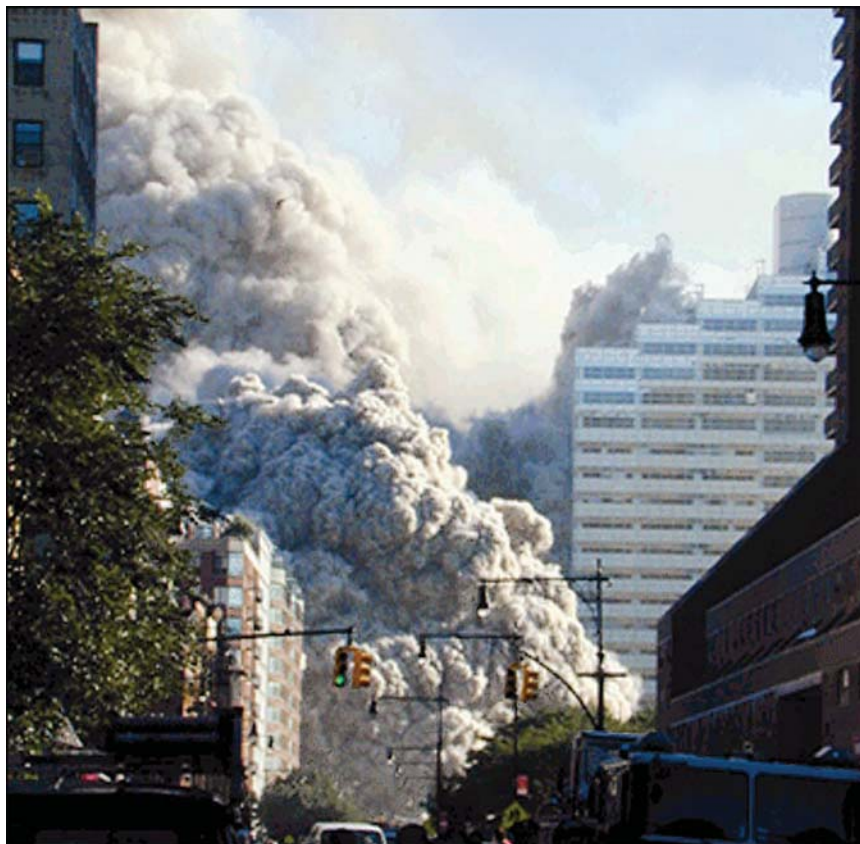
~5:21:10 p.m. WTC 7 collapses completely after burning for approximately 7 hours (Figure 5-25). The collapse appeared to initiate at the lower floors, allowing the upper portion of the structure to fall.

Figure 5-25 Debris cloud from collapse of WTC 7.

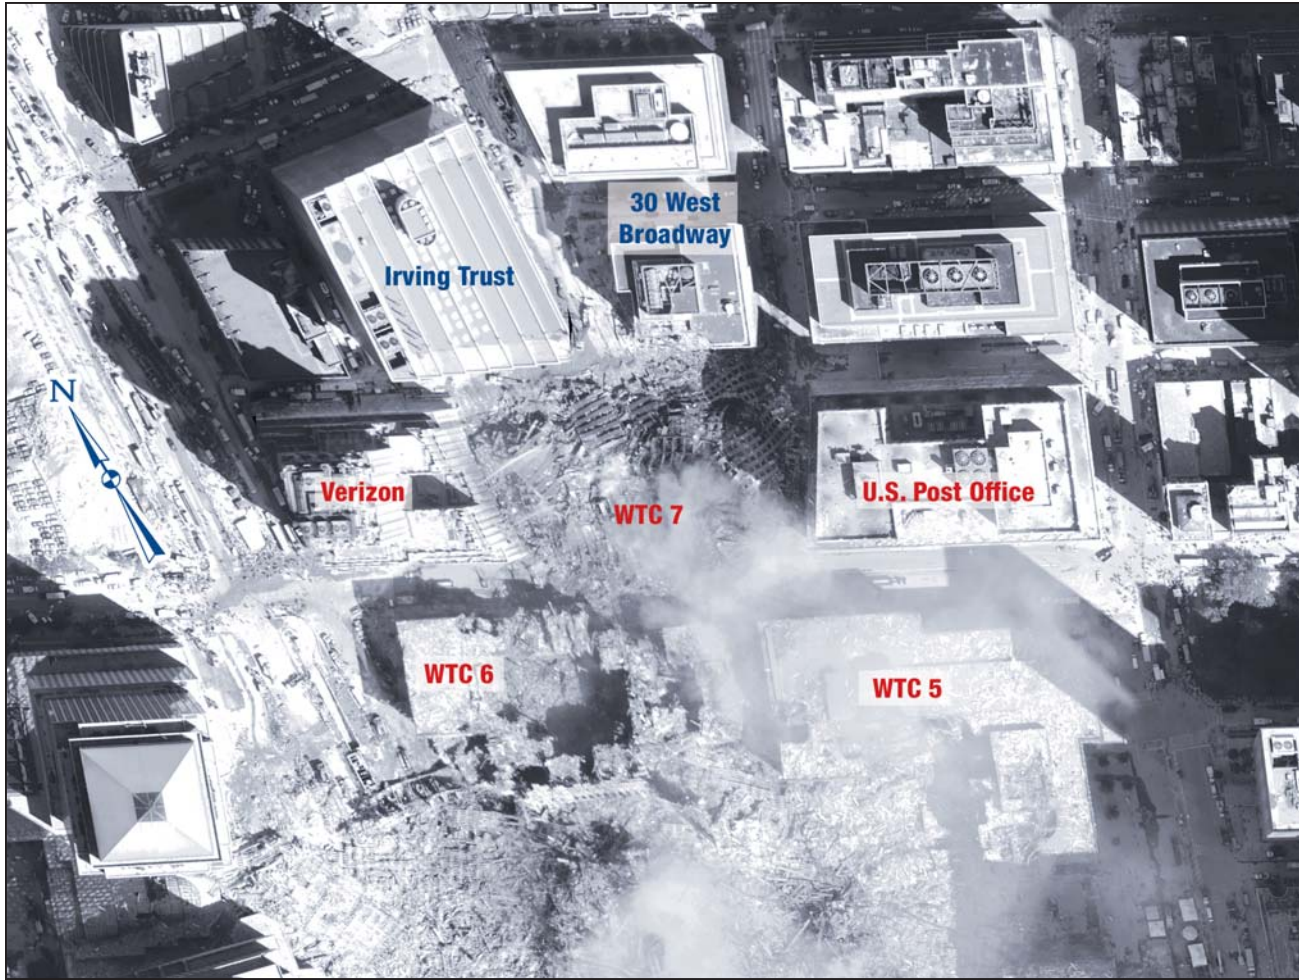
The debris generated by the collapse of WTC 7 spread mainly westward toward the Verizon building, and to the south. The debris significantly damaged 30 West Broadway to the north, but did not appear to have structurally damaged the Irving Trust building at 101 Barclay Street to the north or the Post Office at 90 Church Street to the east. The average debris field radius was approximately 70 feet. Figures 5-12(C) and 5-26 show an approximation of the extent of the debris after the collapse of WTC 7.

Figure 5-26 Debris generated after collapse of WTC 7.
