5 WTC 7

5.1 Introduction

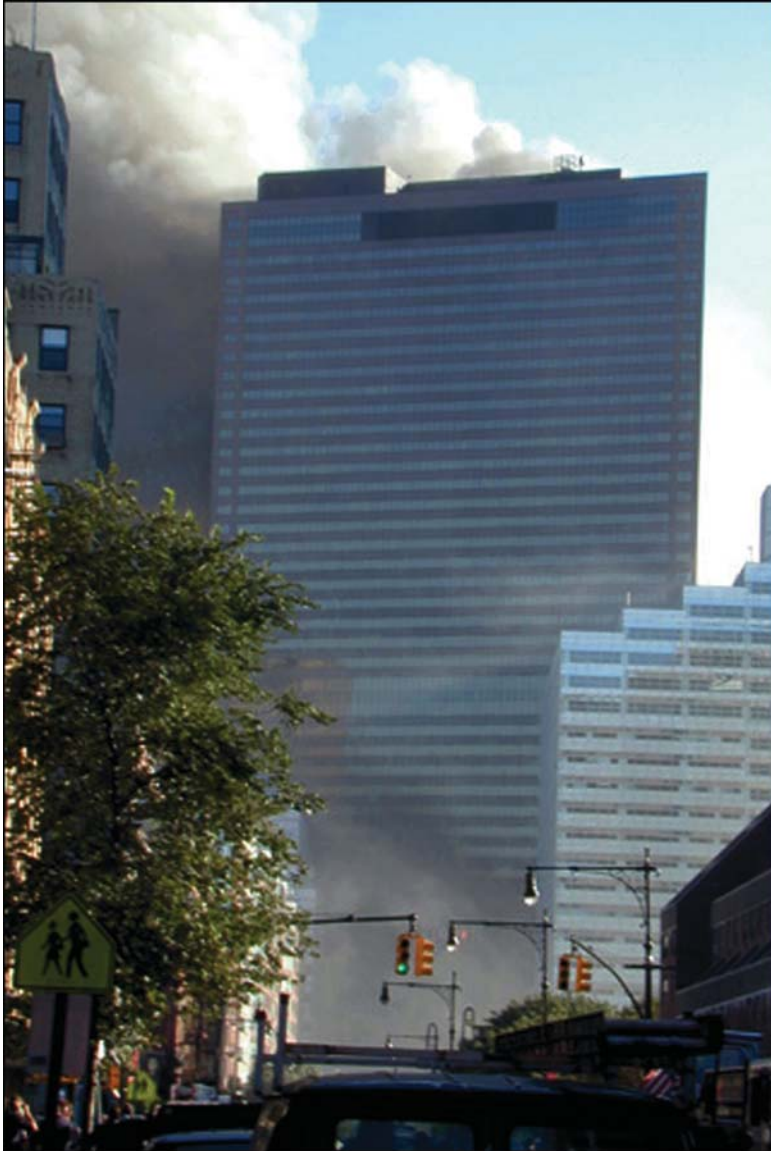
~5:20:33 p.m. WTC 7 begins to collapse. Note the two mechanical penthouses at the roof on the east and west sides in Figure 5-20.

*Figure 5-20
View from the north of WTC 7 with both
mechanical penthouses intact.*
